*Roof leaks in cold regions: School at Chevak, Alaska*

# CRREL Report 80-11

Wayne Tobiasson and Philip R. Johnson

April 1980

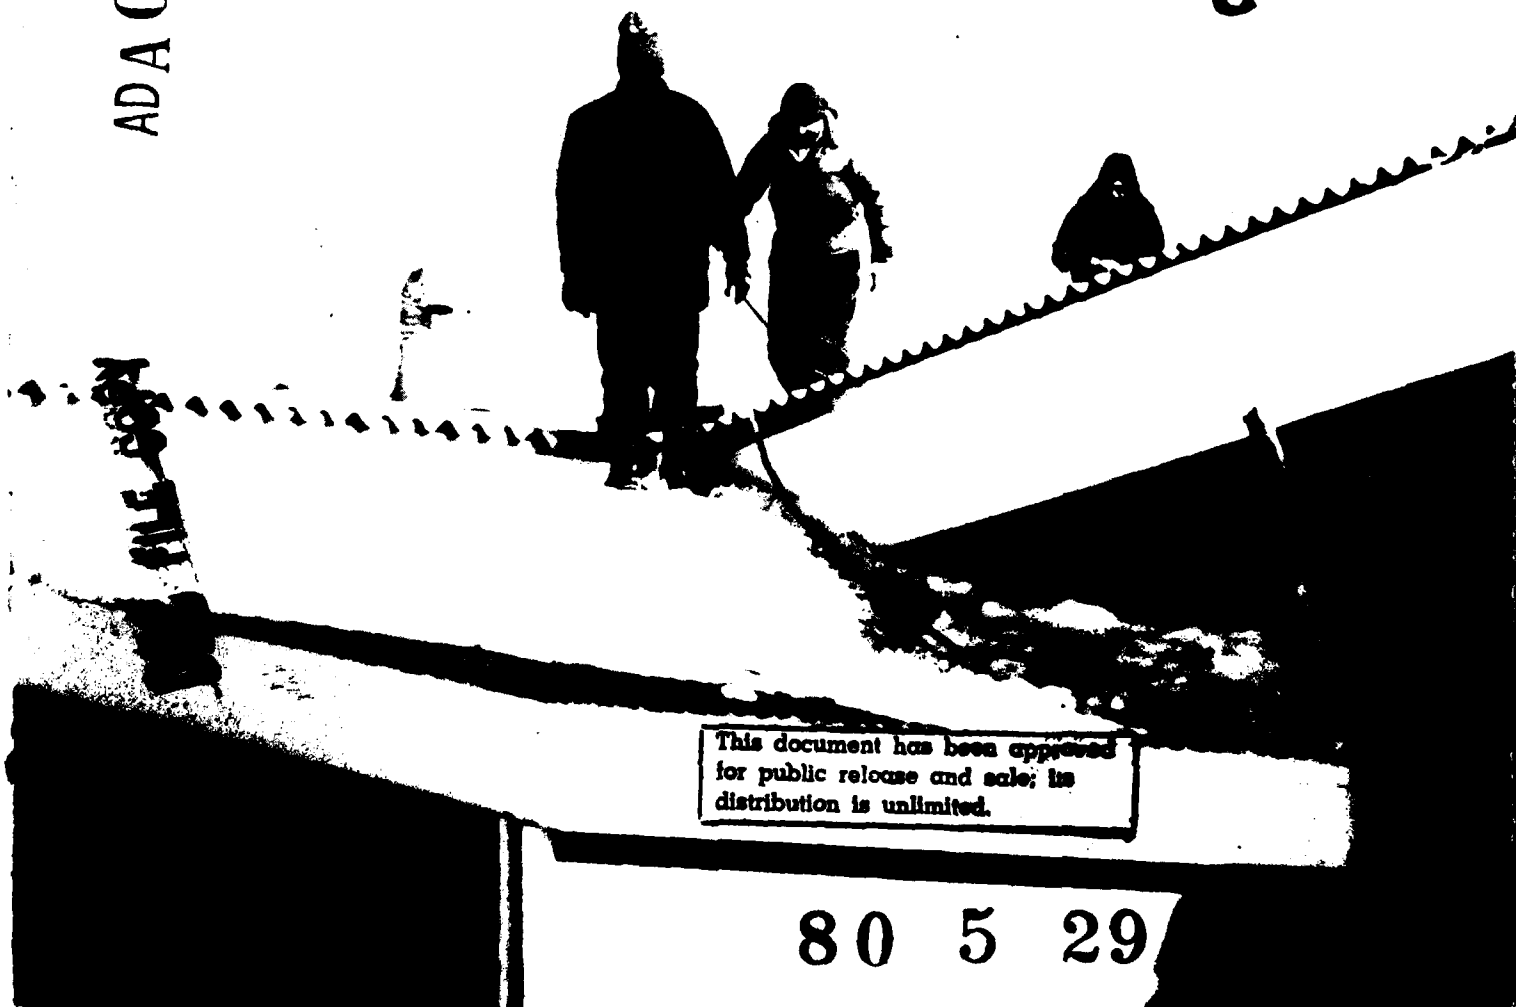
*Cover: Inspecting "problem valley" of BIA  
school roof. (Photograph by P. Johnson.)*

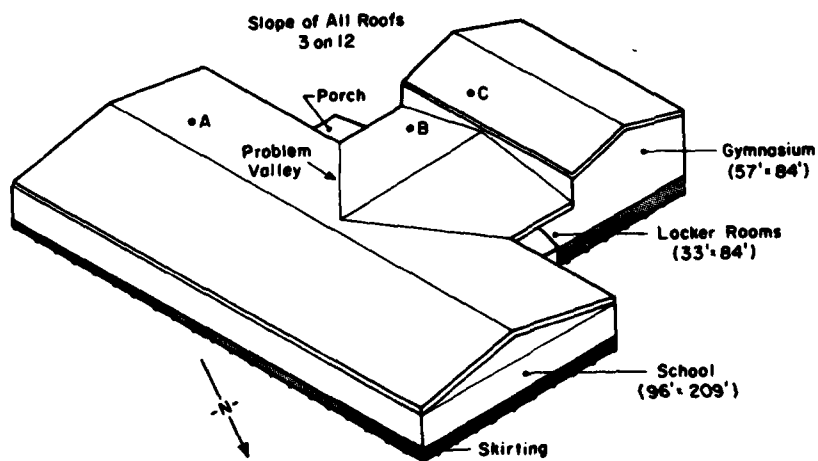
Figure 2. Isometric drawing of Chevak school.

Once the building was occupied, severe leaks developed in the areas of the roof valleys, particularly in the lower portion of the "problem valley" shown in Figure 2. Valley leaks were caused by entry of snow meltwater. These leaks did extensive damage to the suspended ceilings and threatened to ruin the carpet and other inside furnishings.

were lifted at points A, B and C in Figure 2. A small amount of frost was present on the underside of the roofing at point A. A quarter-inch of frost was present at B and 3/8 in. was present at C where some ice was observed on the insulation. These observations convinced all concerned that large quantities of warm moist air from within the building passed into the roof through gaps in the plywood deck and others in the insulation above. The underside of the cold corrugated metal roofing was an excellent condenser and, as the warm moist air passed up through the roof sandwich, frost formed on the metal. Warmer weather and sunshine warmed the frosted underside of the corrugated metal roofing. At some point it was warm enough to melt the frost and meltwater dripped onto the insulation where it either refroze, or in warmer weather flowed downslope. At a gap or seam in the insulation, the water flowed down to the deck. Since there were many gaps in the plywood deck, the water leaked into the building.

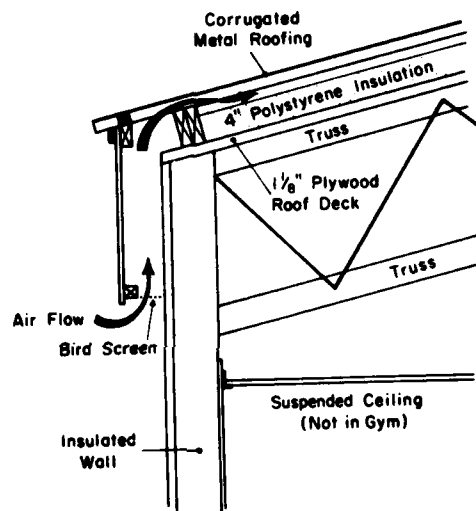
Figure 4. Detail of ventilated eave.

Snow infiltration leaks developed during the late fall and early winter of 1975 while the buildings were closed-in but still being finished. Water entered the building in many areas at seams in the plywood roof deck. Some of the metal roofing was removed and it was found that snow had blown into the roof through the eave vents (Fig. 4) and was packed in the shallow ventilation space between the top of the insulation and the metal roofing. When the building was heated, the snow melted and the meltwater entered the building.

These leaks were easily cured. BIA personnel sealed the vents with plywood, making it impossible for snow to blow into the roof at the eaves.

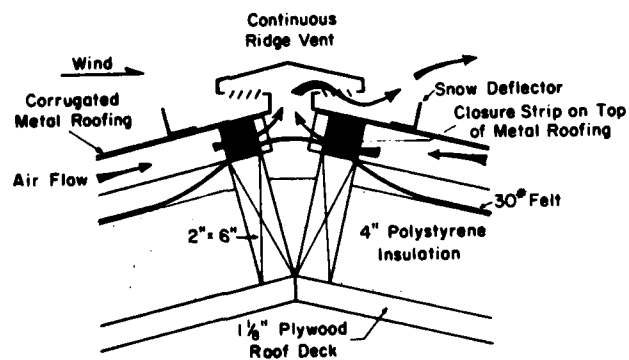
Figure 5. Detail of ventilated ridge.

The ridge is the only safe place for maintenance personnel to walk along these roofs, particularly when there is snow on them. Accordingly, the ridges have been used as foot paths and the ridge vents (Fig. 5) have been flattened against the ridges. Although crushed, some air can still pass through them. The flattened ridge vents should be removed and replaced with elastomeric closure strips and a solid galvanized cap, robust enough to sustain foot traffic. Every 20-ft, the ridge cap should be penetrated with a 2-½-to 3-in.-diam, 24-in.-high black-painted vent stack (upside-down J). The eaves should remain blocked to preclude snow infiltration. If the roof is vapor-sealed as recommended above, we expect that the combination of local winds, air leaks in the metal roofing, and the modified ridge ventilation system will provide enough air movement to facilitate the small amount of summer drying required by the roof.

The ventilated ridge cap was replaced with a solid ridge cap vented every 20 ft with an inverted J.

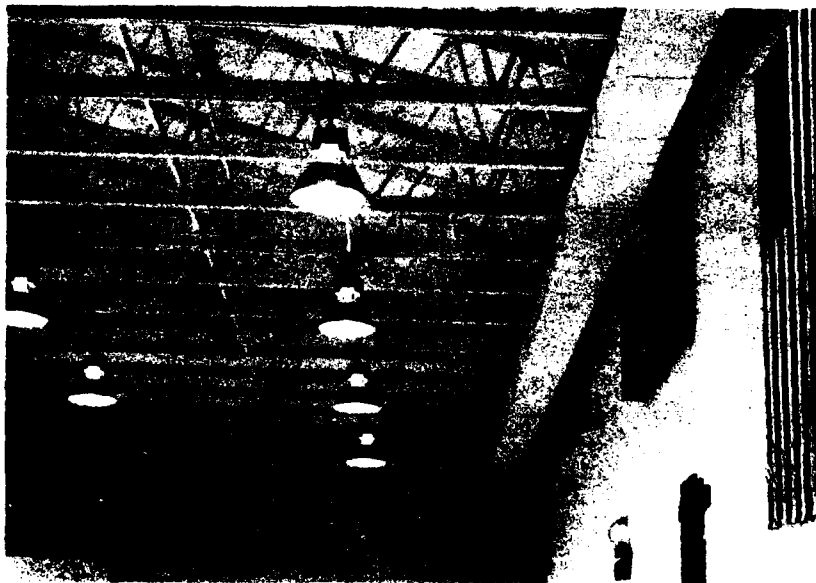
*Figure 7. Inside the gymnasium.*

Roof leaks were observed in the gymnasium on 21 March 1978. The outside air temperature was around 20°F, the wind was almost calm, and the sun was shining. During the afternoon several roof leaks developed in the gymnasium near the ridge on the west-facing (sunlit) slope that persisted until late in the day. This was the warmest portion of that roof. Since there was no snow or ice on the roof at that time, it appeared that frost and ice within the roof was melted.

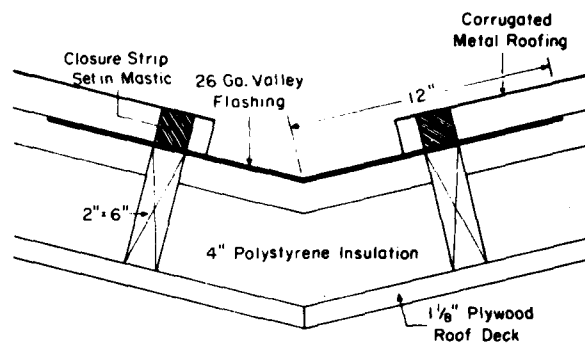
Figure 8. Valley detail.

Figure 8 is a cross section of the Chevak school's roof valley. Considering the thermal movements to which the metal is subjected, it must be assumed that the seals between the flashing, closure strip and corrugated metal are not water-tight. As long as the valley is clear, water drains down the valley and off the roof. However, when the valley contains slush and ice, meltwater rises in the valley and gets behind the closure strips (Fig. 8). Since the depth of the channel provided by the valley flashing is only about 2 in., it does not take much ice and slush to cause water to overtop the flashing and enter the roof.

With the corrugated metal roofing temporarily removed, the valley flashing should be widened. The existing width of 2 ft may be adequate near the ridge, but a width of 4 ft or more seems necessary at the eaves. A quality sealant should be used when placing the new valley closure strips. Permanent electrical heating cables should be installed in each valley.

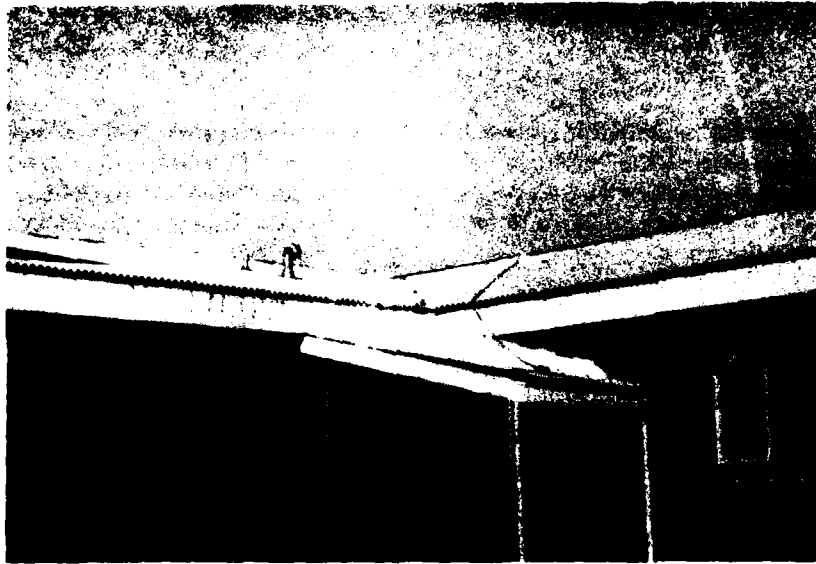
During the inspection, a localized problem was observed at the eave of the "problem valley." Water draining down this valley falls on the sloped roof of an unheated porch (Fig. 10 and cover). Snow drifts onto this roof, and meltwater from the valley soaks into the snow and may freeze, creating heavy ice loads. During warm weather the ice melts loose and slides off this roof. This introduces a potential danger. A heat tape placed down the porch roof would allow drainage and minimize these problems.

*Figure 10. Porch roof on which snow and ice accumulates below the "problem valley."*

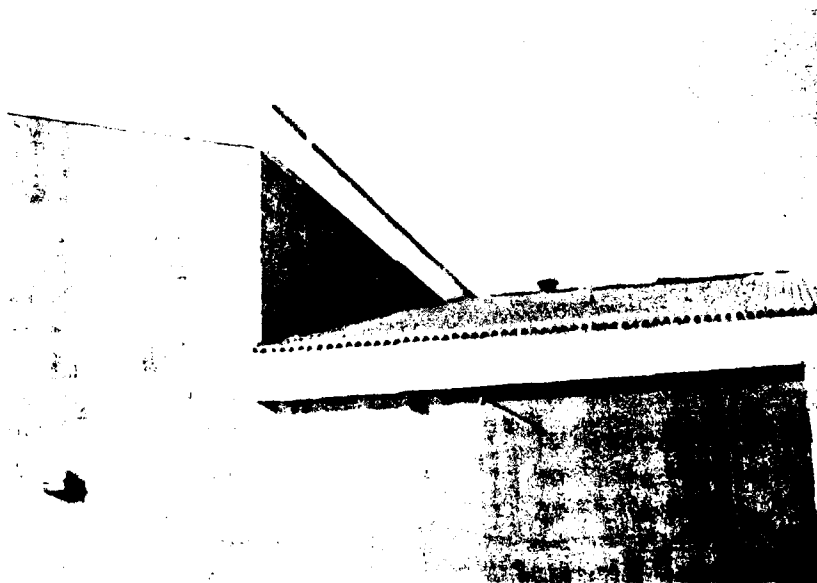
Leaks also developed at the intersection of the locker room roof and the gymnasium wall (Fig. 11). Water from these leaks damaged walls in the boys' and girls' locker rooms.

We did not investigate the leaks at the intersection of the gymnasium wall and the locker room roof. BIA personnel speculated that meltwater from the gymnasium roof was entering the ridge vent of the locker room roof where that roof intersects the wall of the gymnasium (Figs. 2 and 11).

When the roof was opened for repair and modification in 1979, the actual cause of this problem was found to be a missing piece of flashing along the gymnasium wall. This finding emphasized the difficulty of determining the cause of roof problems by visual examination only.

*Figure 11. Intersection of gymnasium wall and locker room roof.*

When the corrugated metal roofing was removed it was found that flashing had not been installed along the upper 4 ft of the roof at the gymnasium wall/locker room roof intersection. Water draining from the gymnasium roof found easy entry into the building because of this construction deficiency. Flashing was installed.
